BULLETIN ACD98-156

DATE: October 26, 1998

SUBJECT: DURASTOP TECHNICAL BULLETIN
RE: PRMATURE WEAR AND/OR OVERHEATING
FRONT BRAKES .

Vehicles Involved: 1988 through early model 1990 Pontiac LeMans equipped with solid front disc brake rotors and 1.6L engines.

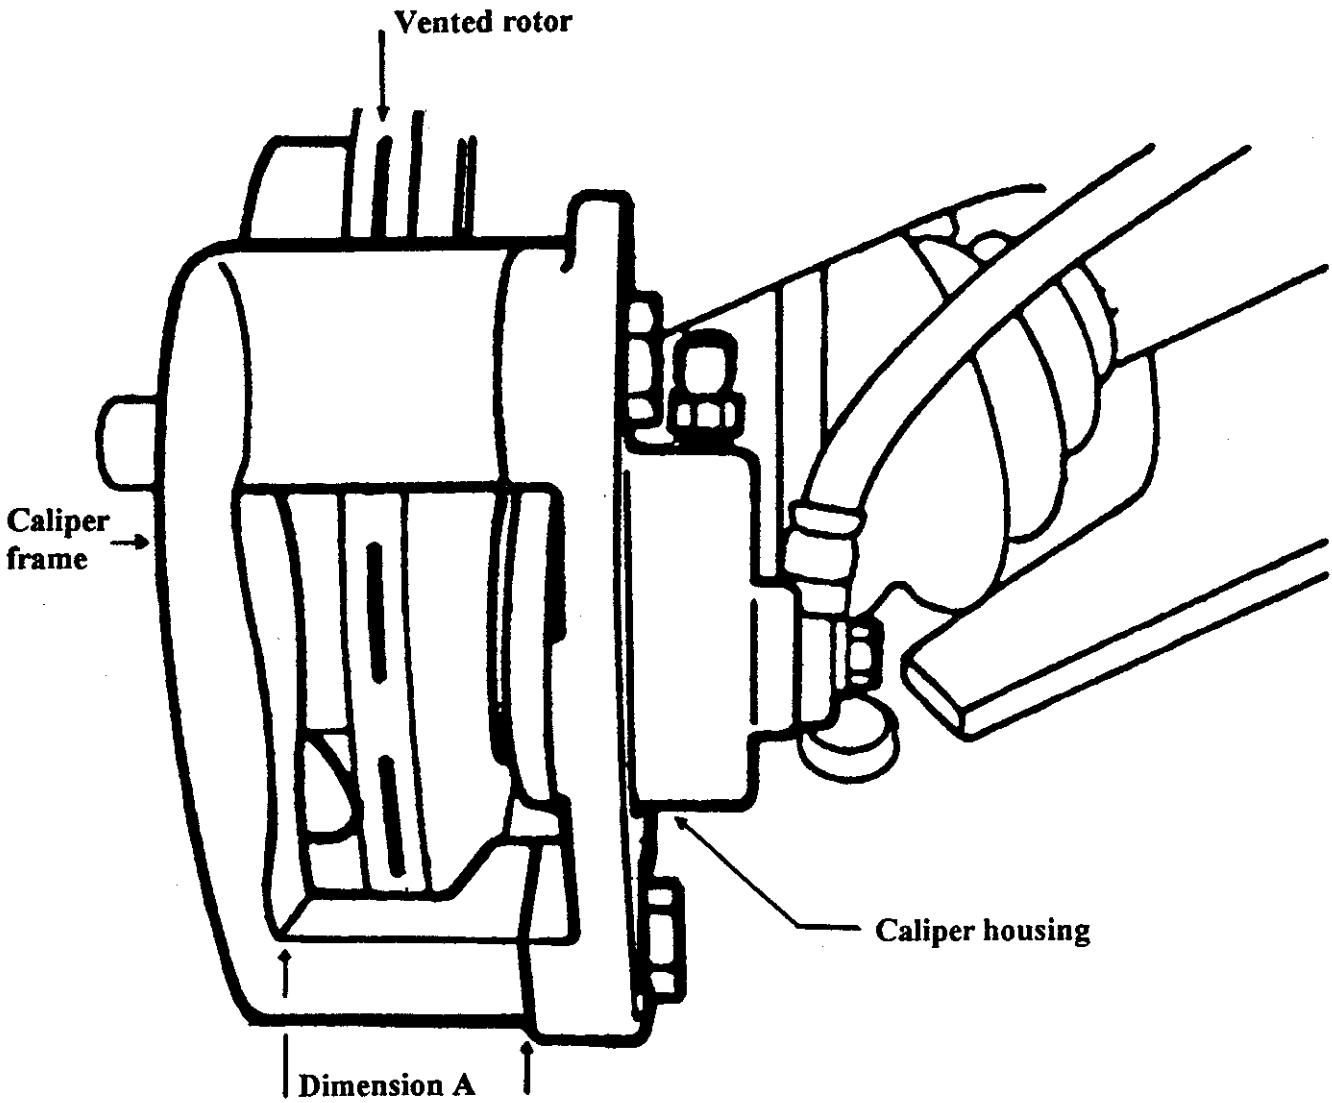
fig. 1

Note: The LeMans use calipers that consist of two main parts, the piston housing and the caliper frame (fig. 1). These must be used as a matched set to allow for the thicker vented rotor. Do not reuse the early design caliper frame.

Note: Late design caliper frame is larger to allow for vented rotor (dimension A).
