BULLETIN ACD98-164
DATE: November 30, 1998

SUBJECT: DURASTOP TECHNICAL BULLETIN
RE: CHECKING LATERAL RUN-OUT ON COMPOSITE
ROTORS

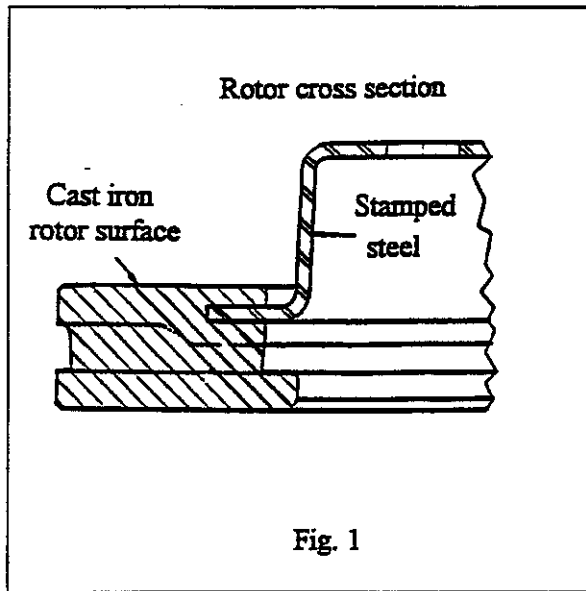
Composite design brake rotors are utilized by vehicle manufacturers to provide substantial weight reduction which can increase overall fuel economy. Unlike a full cast rotor, a composite rotor consists of a stamped steel center hub section combined with a cast iron brake surface (see fig. 1). During the manufacturing process the center hub face is compressed by a special fixture prior to machining the braking surfaces. When the vehicles wheels are installed and the lug nuts are torque to the proper specifications, the stamped steel portion of the rotor is compressed in a similar fashion. This insures that the rotor will have a minimum amount of run-out and will function properly.
